# Asus X751L DVD Drive Replacement

Use this guide to replace the DVD drive on your Asus X751L.

Written By: Carl Ravina

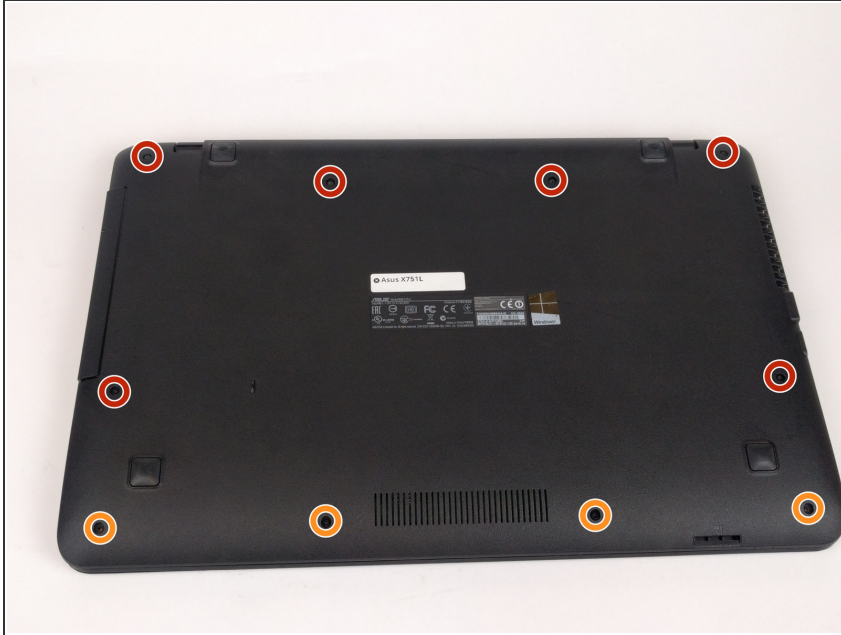
## Step 1 — Keyboard

- With the screen closed, place your laptop upside-down with the front facing you.
- Remove the six 14.6mm Phillips #00 screws.
- Remove the four 6.6mm Phillips #00 screws.

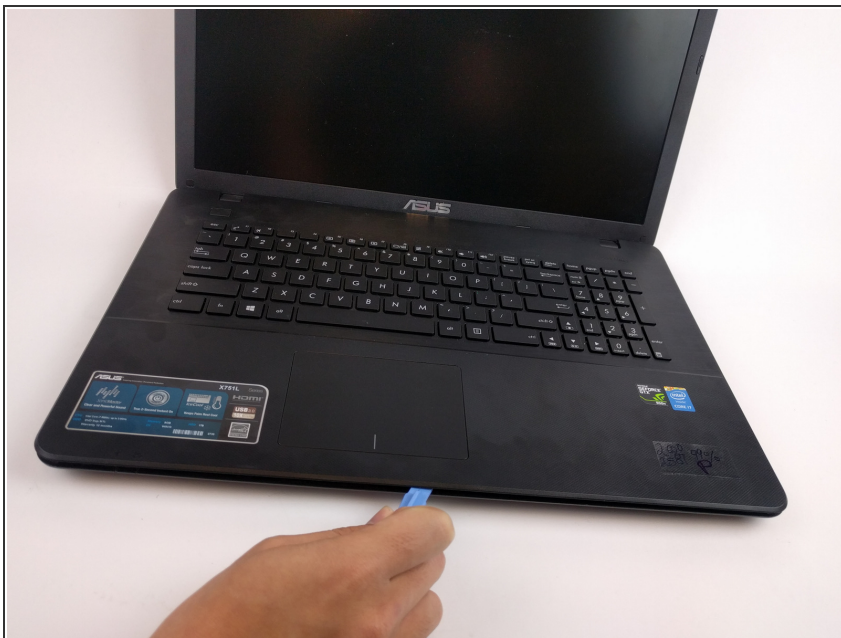
## Step 2

- Flip the laptop over and open the lid.
  - Pry around the edges of the laptop base using the plastic opening tool.
- ⚠ Prying too hard can break the plastic clips.

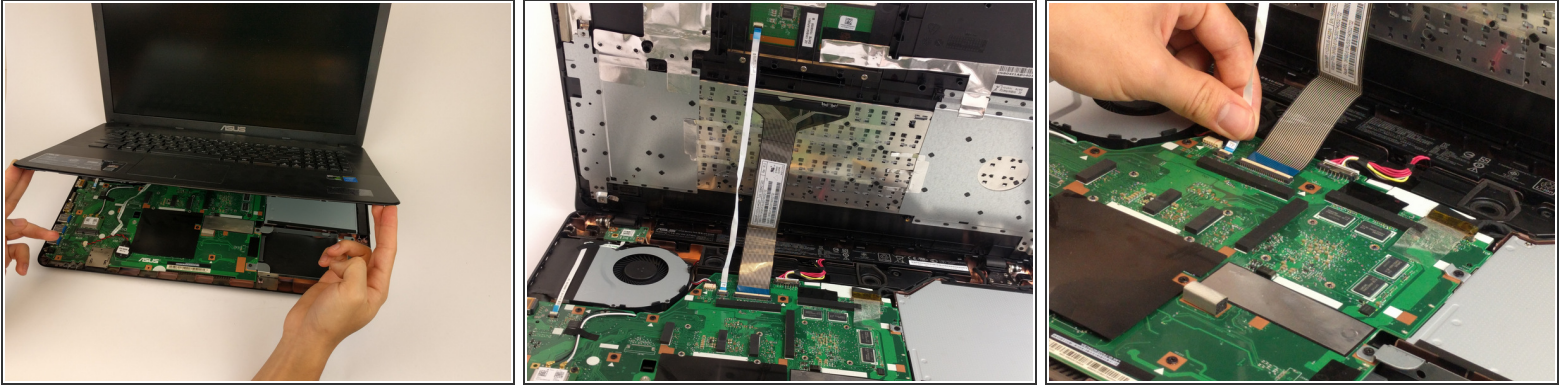
## Step 3

- Carefully lift the keyboard up.
  - ⚠ Be very careful when lifting the keyboard up. Two zero insertion force (ZIF) cables are between the keyboard assembly and the motherboard. Do not lift the assembly too high.
- Disconnect the two ZIF connectors from the motherboard using your fingernail to lift the cream-colored tab.

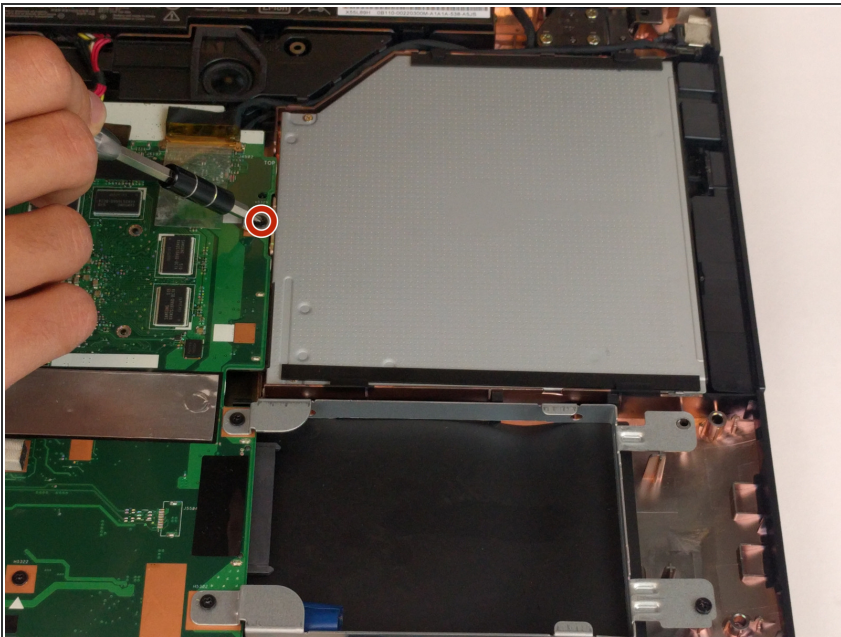
## Step 4 — DVD Drive

- With the keyboard panel open, face the laptop with the internal components facing towards you.
- Remove the single 4.6mm Phillips #00 screw.

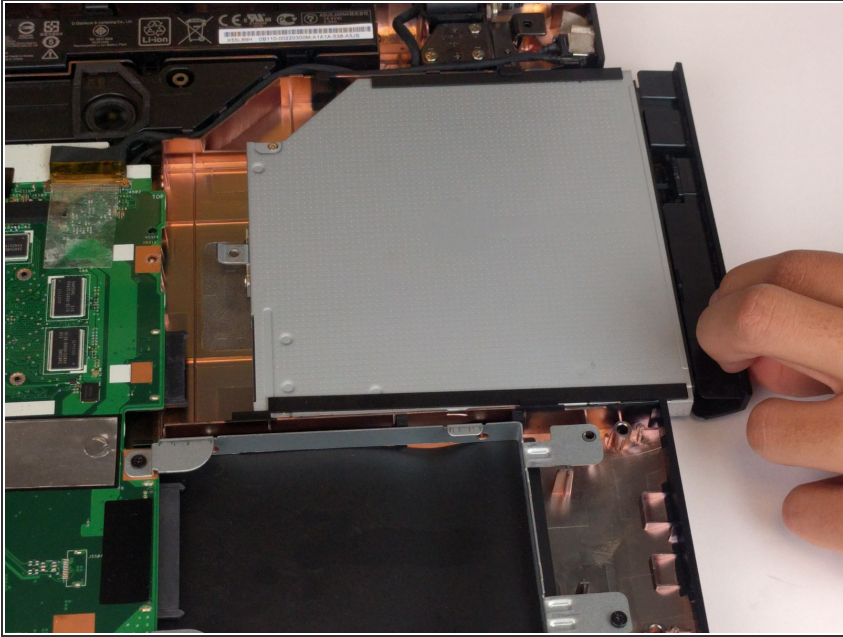
## Step 5

- Pull the optical drive out.

To reassemble your device, follow these instructions in reverse order.
